HA10-007

ITB10-051

## 2010 G37; A/C BLOWS WARM AT IDLE

**APPLIED VEHICLES:** 2010 G37 Sedan (V36) A/T, non-sport, 2WD  
 2010 G37 Coupe (CV36) A/T, non-sport, 2WD

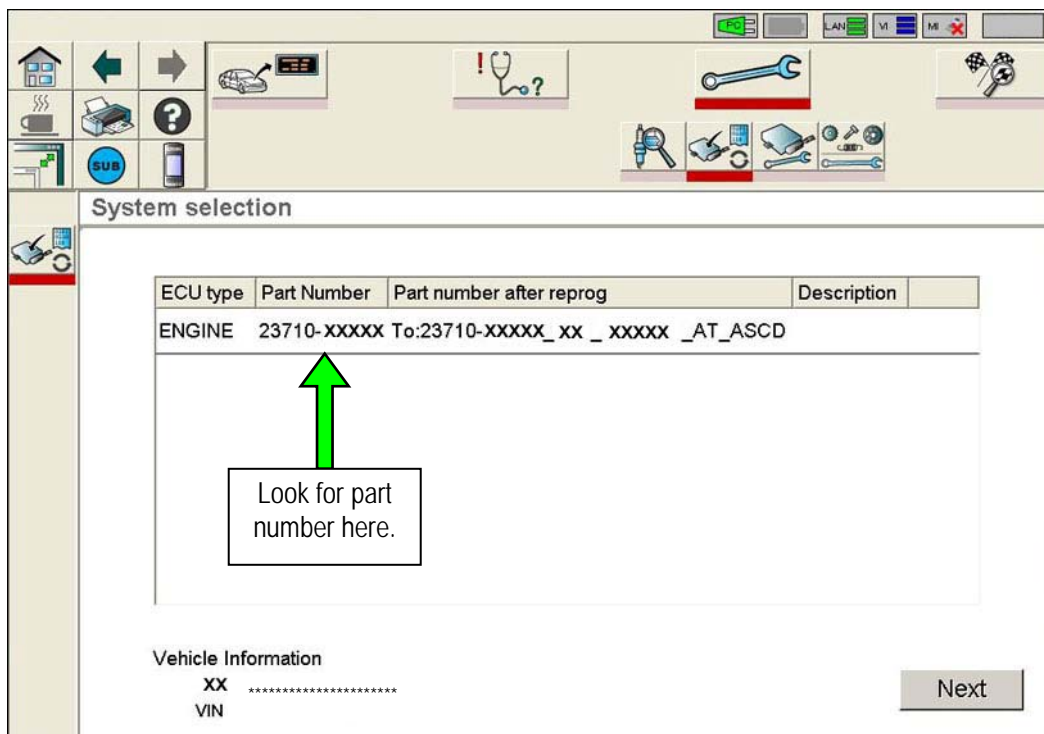
2. When you get to the ECM Reprogramming screen shown in Figure 1, confirm this bulletin applies as follows:

- A. On your C-III screen, look at the **Part Number** column (see Figure 1 example).
  - If this column is **blank** (no part number listed), this **bulletin does not apply**.
  - If a Part Number is listed, write it on the Repair Order and then go to Step B.

B. Compare the Part Number you wrote down to the numbers in the **Current ECM Part Number** column in **Table A** below.

- If there is a match, this bulletin applies. Continue with the reprogramming procedure.

**NOTE:** If there are two lines (two reprogramming options) on your C-III screen, use the one that does not have the message "Caution! Use ONLY with ITBXX-XXX".

- If there is not a match, this bulletin does not apply. Close C-III and refer to ASIST for further diagnostic information.

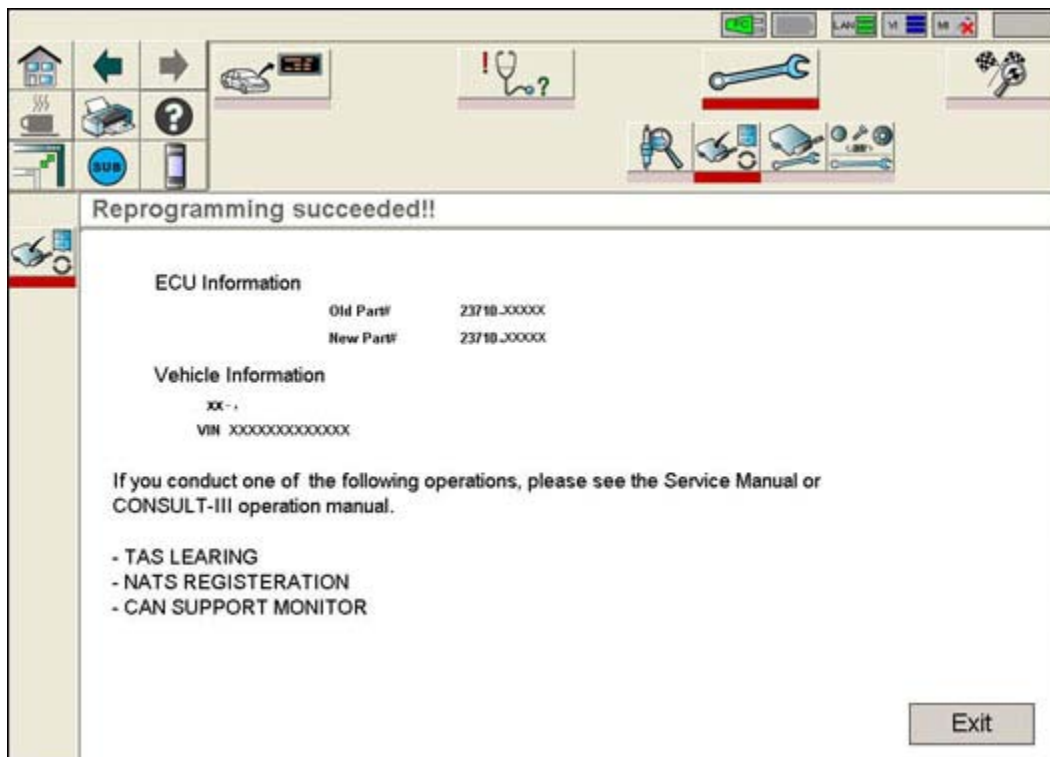
3. If this bulletin applies and you have performed ECM reprogramming, the screen in Figure 2 (below) appears when reprogramming is complete.

**NOTE:** If the screen in Figure 2 does **NOT** display (reprogramming does **NOT** complete), click [here](#). This links to the ECM Reprogram Interruption Recovery General Procedure.

- Print the page from C-III (C-III page example below) and attach it to the Repair Order for Warranty documentation.
